DuPont global PV reliability

2020 Field analysis

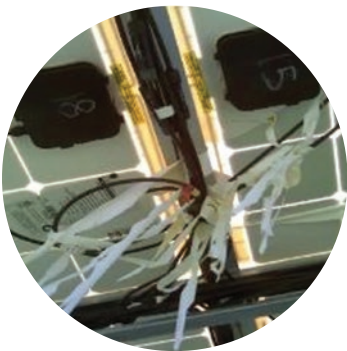
5 years
Eastern Canada

- These failures are prevalent along busbar ribbons, but with continued weathering can extend to cell gaps and other regions.
- Arcing and shorts often lead to localized burn-through and sometimes full module fires.
- Reported inverter tripping and ground faults.

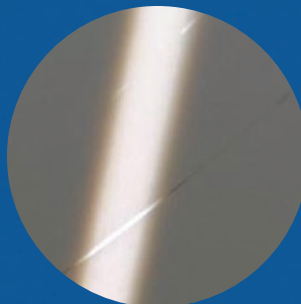
A photovoltaic plant in France discovered that, after 8 years of use, performance of their modules was declining year over year and that many modules were displaying widespread backsheet cracking. This had led to a degradation of insulation resistance (IR) in the solar modules over time, leading to unsafe working conditions as a result of electrical hazards. All PA backsheets and 10% of PVDF backsheets exhibited cracking.

**Widespread
backsheet cracking**
PVDF

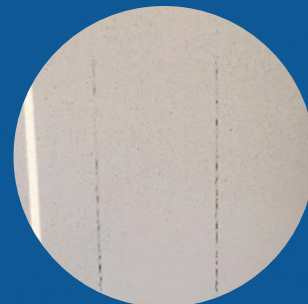
**Widespread
backsheet cracking**
PA

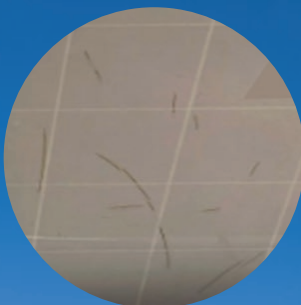
One solar field in Arizona, USA utilized a mixed bill of materials. After 7 years of use, widespread cracking was found in PVDF backsheets. The entire field needed to replace modules in order to maintain operation and energy production and, as a result, sustained multimillion-dollar losses. No defects were observed in modules made with Tedlar® PVF-based backsheets.

**Widespread
backsheet cracking**
PVDF

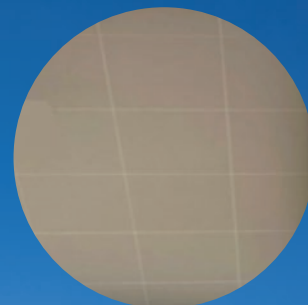
No defect
Tedlar® PVF
